IP International Journal of Maxillofacial Imaging

Original Research Article

Evaluation of surface changes of stainless steel miniplates and screws following retrieval

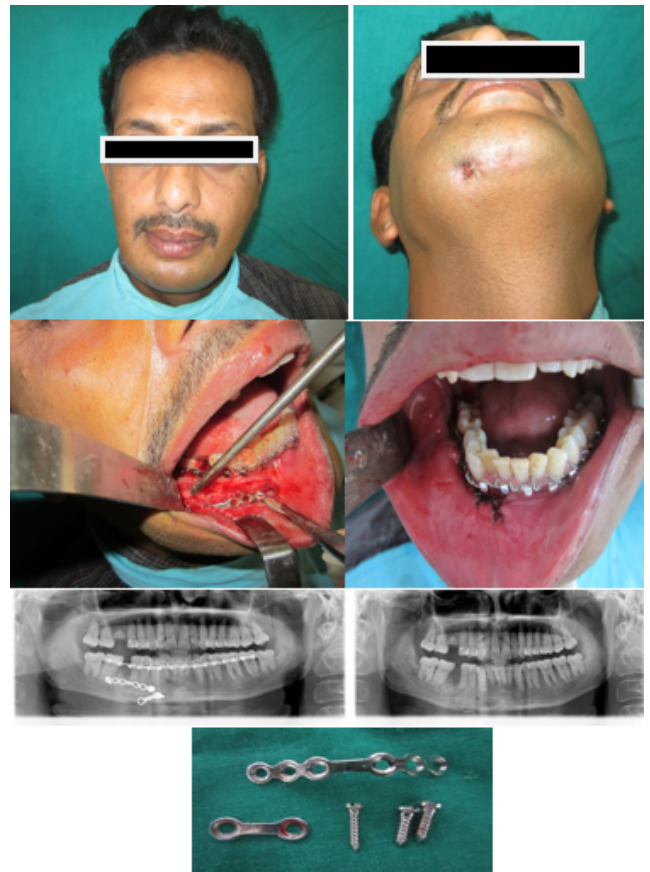
Fig. 1: Implant retrieval

After the concerned ethical committee approval and informed consent, 20 patients treated for maxillofacial trauma at the Department of Oral and Maxillofacial Surgery, Meghna Institute of Dental Sciences, Nizamabad were selected. From them stainless-steel bone plates and screws were retrieved through intraoral approach which were cleaned under running water, dried and stored in a sterilized container for further evaluation (Figure 1).

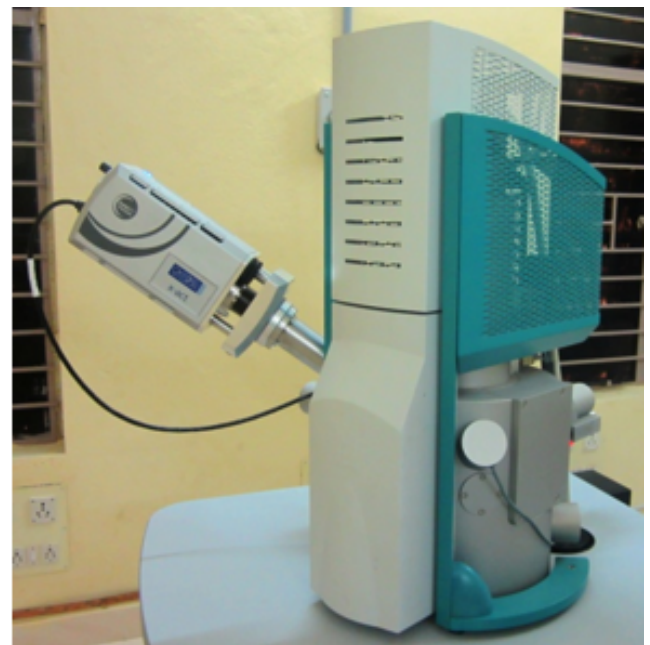
Fig. 2: Scanning electron microscope (Tescan; Model: Vega 3LMU)

The retrieved implants were evaluated for the surface changes like corrosion, surface roughness and micro-fractures using stereomicroscope and scanning electron microscope where the initial evaluation was done under scanning electron microscope (Tescan; Model: Vega3LMU) at the Department of Metallurgical and Material Engineering, National Institute of Technology, Warangal, Telangana State (Figure 2). Then another evaluation was done under stereo microscope at the Department of Oral and Maxillofacial Pathology, Meghna Institute of Dental Sciences Nizamabad (Figure 3).

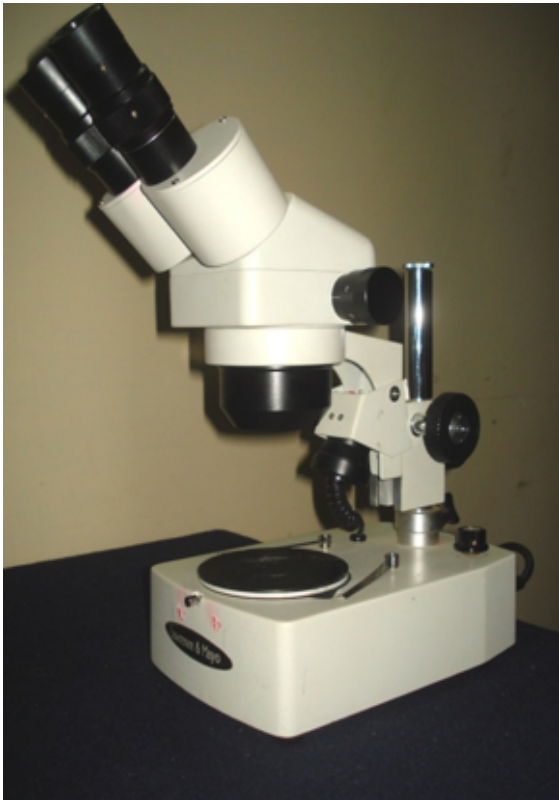
Fig. 3: Stereomicroscope

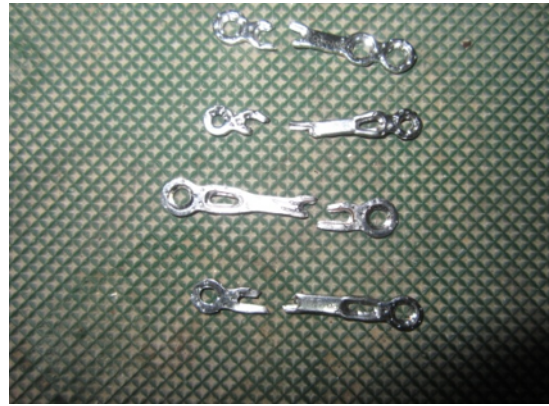
Fig. 5: Miniplates tested for tensile strength.

After the surface change evaluation, the implants were subjected to the universal testing machine (Dak Systems Inc.'s Series 9000) to measure the tensile strength where the plates were mounted onto the jaws of the testing machine and tested at a constant cross head speed of 2mm/min. Finally, the peak load at which the plates failed in tension was noted down as ultimate stress (Figures 4 and 5).

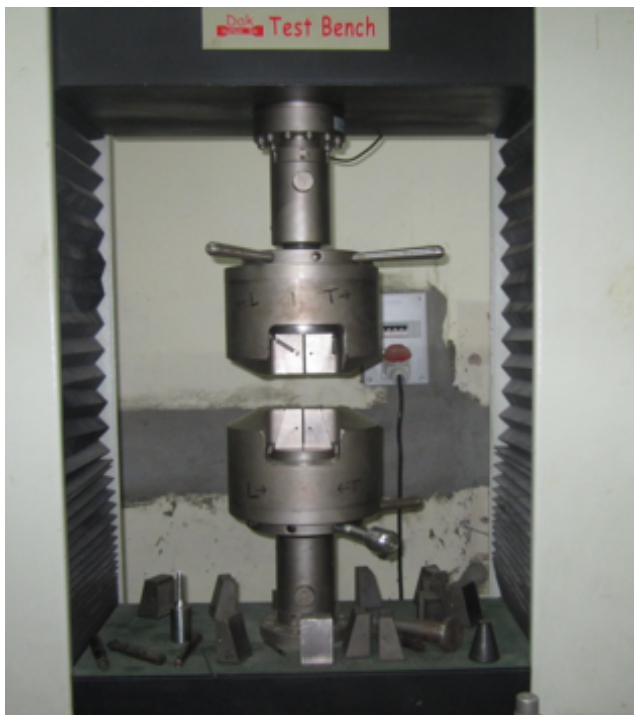
Fig. 4: Universal testing machine (Dak Systems Inc.'s Series 9000)
