Understanding artifacts in cone beam computed tomography

Abhishek Sinha^{1,*}, Anuj Mishra², Sunita Srivastava³, Pooja M Sinha⁴, Akhilanand Chaurasia⁵

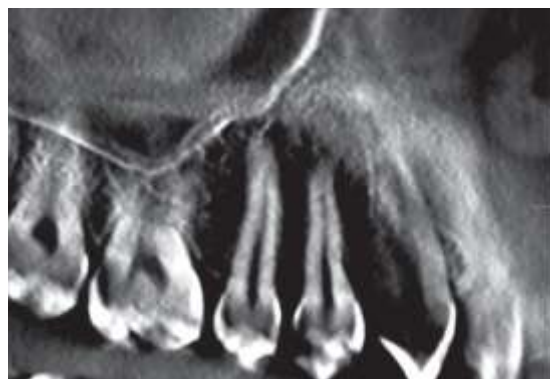
Fig. 2: Under sampling due to insufficient basic projections

- Partial volume averaging:** When the selected voxel resolution of the scan is greater than the spatial or contrast resolution of the object to be imaged. Partial volume averaging artifacts occur in regions where surfaces are rapidly changing in the z-direction (e.g. in the temporal bone).
- Under sampling:** This is a type of aliasing artifact. It is seen when very few basis projections are provided for the reconstruction.
- Cone beam effect:** This type of artifact is seen in the peripheral portions of the scan and is seen because of the divergence of X-rays in those areas. The outcome of cone beam effect is image distortion, streaks, and peripheral noise.^[6,8]

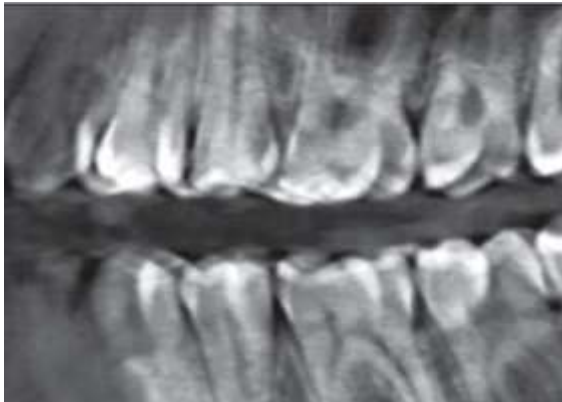
Fig. 4: Fault due to patient movement

Patient-related artifacts: Patient motion can cause faulty registration of data within the image. Because of the relatively long acquisition times (compared to conventional radiography) and volumetric image acquisition, motion artifacts are common in CBCT. These artifacts can be attributed to improper patient stabilization. Small motions cause image blurring and larger physical displacements produce artifacts that appear as double images or ghost images. This results in poor overall image quality.

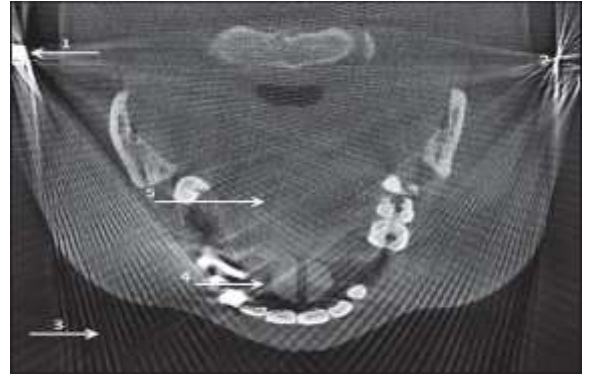
Fig. 5: Image deterioration due to heavy metal. Image also shows the metal earrings, streaks, bands, mouth block, and ring artifact

Scanner-related artifacts: These artifacts typically present as circular or concentric rings centered on the location of the axis of rotation.^[6] If one of the detectors is out of calibration on a scanner, the detector will give a consistently erroneous reading at each angular position, resulting in a circular artifact. A scanner with solid-state detectors, where all the detectors are separate entities, is in principle more susceptible to ring artifacts.^[9] However, they can impair the diagnostic quality of an image, and this is particularly likely when central detectors are affected, creating a dark smudge at the center of the image. Currently there is no evidence of ring artifacts on CBCT machine in dental radiology literature.
